An Investigation of Damages in Low Power Wind Turbine Blades

Abstract

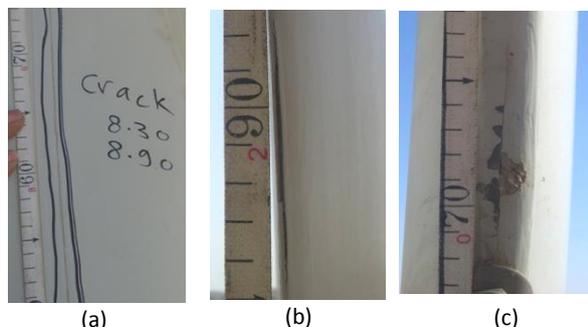
Longitudinal cracks (LCs) are parallel to blade length. **Error! Reference source not found.** (a-c) shows some examples of LCs in 100 and 300 kW rotor blades. Relatively long LCs are observed at the root or in the cover of the aerodynamic zone. The longest LC (60 cm long) shown in **Error! Reference source not found.**-a is found at the transition zone, where abrupt change of material thickness exists [11]. **Error! Reference source not found.**-b shows an LC located at 2.85 m away from the blade tip of 300 kW turbines and grows in the bonding layer of the two shell halves. Moreover the LC in **Error! Reference source not found.**-c is accompanied with some damages and removal of the gelcoat on both sides of the crack.

Figure 4 Examples of longitudinal cracks found in the blades of 100 kW (a and c) and (b) 300 kW wind turbines.

The main causes of LCs either near the blade tip or near the hub could be contributed either from the manufacturing process or from the operating conditions. The blade is made of two half shells joined together with about 1 cm thick bonding material at the trailing edge, **Error! Reference source not found.**. The shell thickness decreases from the root to the tip. The thickness was found to change from 17 to 27 mm near the blade root of an equivalent 300 kW wind turbine [1]. Moreover the shell thickness decreases gradually towards the tip, causing a required decrease of rigidity towards the tip. The drawback of low rigidity of the rear third of the blade is the increased deflection leading to high shear stresses at the interface between the rotor shell and the bonding materials. This can lead to decohesion or cracks at the trailing edge bonds, which is probably the reason of LCs found near to the tip (**Error! Reference source not found.**-b).

Also, during joining of the two shell halves, two types of defects may occur. One can be called "oversum" when excess bonding material exists and the other can be called "undersum" when unfilled spaces between the two shell halves exist. Oversum defects at the shell edges are treated by grinding while undersum defects are filled by bonding material. The abrupt change of material thickness at the root and the aerodynamic cover of the blade leads to similar damages in 300 kW turbine blades [1], which could be classified as fatigue damage. The reason for the existence of LCs at the root and cover of the aerodynamic zone (**Error! Reference source not found.**-a) could be due to the interaction of fatigue loading and geometric change of the blade, which increases the severity of stresses [12]. Such

LCs should be structurally repaired to extend the life of the working blades.

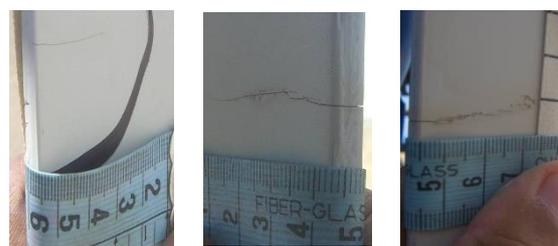
a. Simple TCs grow only in one side of the blade i.e., only in one shell half, mainly at the trailing edge and stop at the edge of the blade. An example of such cracks in the 100 kW wind turbine is shown in **Error! Reference source not found.** a. On assembly of shell halves some misalignment could occur, and should be corrected by grinding one side of the trailing edge. This can reduce the reinforcing fiberglass, weakens the edge under high loading condition and leads to initiation of such cracks. The straight end of the simple crack (**Error! Reference source not found.**-a) indicates that the resistance from the reinforcing fiber is limited and in could grow further.

b Round TCs grow on both sides of the trailing edge of the blade i.e., through both shell halves of the blade. An example of round TCs found in the 300 kW wind turbine is shown in (**Error! Reference source not found.** b-c). Such crack has a branched river form, due to crack growth obstacles formed from the fiber layers. A round TC can start as a simple TC. Then it can grow further by crossing the trailing edge to the other side. The possible causes of round TCs could be the weak reinforcing at this region, as mentioned earlier. Extensive investigation is needed to examine the presence of enough reinforcement at the trailing edge. Over loading during service can also be a reason of occurrence of round TCs.

Round transverse crack is considered one of the most dangerous cracks, as it crosses the highly loaded edge of the blade. A follow-up inspection plan is designed to monitor the progress of round TCs.

Figure 6 Examples of simple and round transverse cracks in 300 and 100 kW wind turbines.

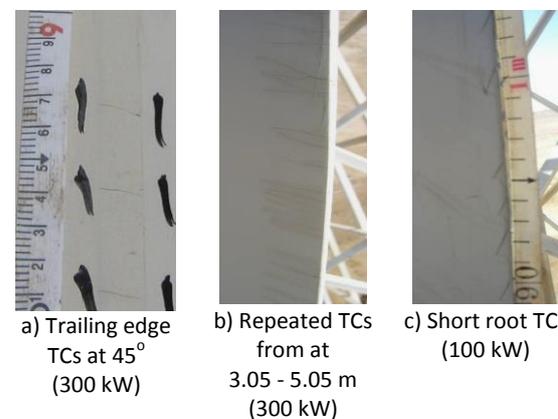
c. Short root TCs are shallow and short (1.5 up to 2.5 cm) and are located between the black line marks in **Error! Reference source not found.**-a. These cracks are found in the blade root of the 100 kW wind turbine. These short root TCs are found as individual cracks or as a group of up to 7 neighboring cracks with 2 to 6 cm inter-crack spacing. These repeated short TCs could be due to excessive cosmetic bonding material to fill any undersum and to treat any geometrical error to get round cylindrical root.

Figure 7 Different forms of repeated TCs in the blades of 300 and 100 kW wind turbines.

d. Repeated simple TCs are found on one side of the trailing edge, as shown in **Error! Reference source not found.**-b, in only one blade of the 300 kW wind turbine. These TCs are mainly superficial and at most it extends to just under the coating layer. This type of cracks could be either due to impact force on the trailing edge from the other side, or due to the stall of the blade. Wind turbine blade stalling is an edgewise vibration [12] due to increasing the angle at which the wind strikes the blade (angle of attack), as shown in **Error! Reference source not found.**-b, and it reduces the induced drag (drag associated with lift). Stalling happens at higher wind speed. If the blade flat side faces directly the wind full stalling (blade stops) may

e. Transverse cracks on 45° with the trailing edge (Error! Reference source not found.-c) are found in turbine blades together with the repeated TCs (Error! Reference source not found.-b). The main cause of these transverse cracks could become clear if the lay-up of reinforcing fiber layers is known. The outer layer (under the gelcoat) is usually randomly oriented, while the next 2 or four layers are most probably arranged at 45° and -45° with the blade length. The cosmetic finishing machining processes may lead to some thinning, so that the subsequent layers (45° and -45°) become nearer to the surface. Vibrations (due to turbine stall) or fatigue loading may weaken the fiber matrix interface and lead appearance of such short cracks.

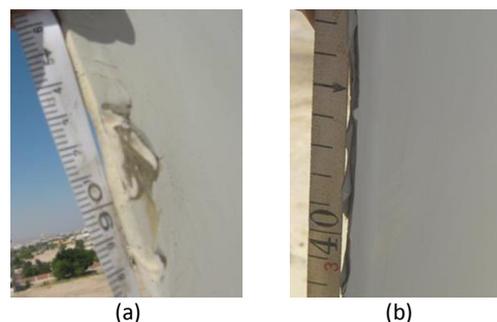
Edge damages as edge cuts or crushing are observed at various positions along the trailing edge of the blades. Error! Reference source not found.-a shows an example of 10 cm edge cuts in the blade trailing edge of the 300 kW wind turbines, at about 3.4 m from the tip. On the other hand edge crushing (Error! Reference source not found.-b) can be found in both 100 and 300 kW rotor blades. The trailing edge in the 300 kW wind turbine blade is quite sharp, therefore any mechanical interaction with a hard body can result in such type of damage. This mechanical interaction may also arise from the impact of the crane lifting basket during transportation, maintenance or washing of the blades.

Figure 10 a) Edge cuts in a 300 kW rotor blade and b) crushing of the trailing edge of a 100 kW rotor blade.

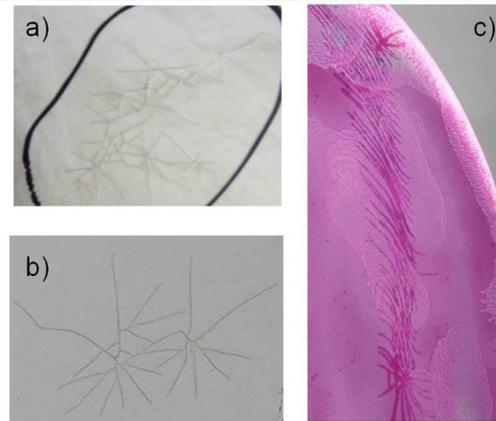
Hair line surface cracks spread over areas with different sizes, and with random orientation or sometimes with a radial orientation trend from a certain point, as shown in **Error! Reference source not found.** (a-c). They are fine shallow cracks on the coating layer of the blade. For better identification of the hair line cracks, liquid penetrant test (PT) is used in some cases. An example for the hair line cracks detected by PT is shown in **Error! Reference source not found.**-c. In many cases hair line cracks are easily detected by VT, due to the contrast of the white gelcoat and the dark fine cracks, **Error! Reference source not found.**a-b.

The nature of the gelcoat layer or the existence of some external forces may be the causes of the hair line cracks. The gelcoat thickness ranges between 0.25 and 1 mm and in most cases it has a thickness of 0.6 mm [15]. Increasing the gelcoat thickness increases the probability of cracking, due to the hard nature of fiberglass reinforced plastic (FGRP). Also impacting the blade body by some external force [15], either during removing the product from the mold or during service can cause such gelcoat hair line cracks. It could finally conclude that the appearance of the hairline crack is due to a combined effect of the suitability of the gel coat to the working and environmental conditions.

Figure 12 Hair line surface cracks found in blade of the 300 and 100 kW wind turbines, (a) and (b) detected by VT and (c) detected by PT

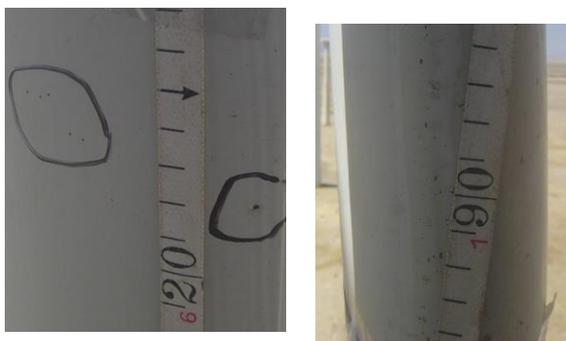
Pin holes or coating pores are small pits in the coating layer of the blade with diameter of ~ 1 mm, **Error! Reference source not found.**-a. Smaller coating holes shown as orange peeling also found in various areas. Distribution of the pin holes along normalized rotor radius is illustrated in **Error! Reference source not found.**. Such pits are of different size areas with diagonals up to 30 cm and pore inter-spacing from few millimeters to 3 cm. Moreover discrete pits with a diameter up to 2 mm are also observed as shown in **Error! Reference source not found.**-b. Such pores are distributed on the 100 kW blades, and over the lower half of the blade of the 300 kW turbines. This implies that the erosion of the blade with dust over the long service life (~ 17 years) could be also another cause for formation of such small pin holes. Existence of such small pores increases the roughness of the blade surface and decreases the aerodynamic performance of the blade [11].

This type of discontinuity is expected in the coating layer during manufacturing as fine pin holes or orange peeling due to entrapped small air bubbles in the gelcoat [15] caused by some technical error concerning of the application distance of the pistol nozzle.

Figure 14 Examples of pin holes/coating pores.

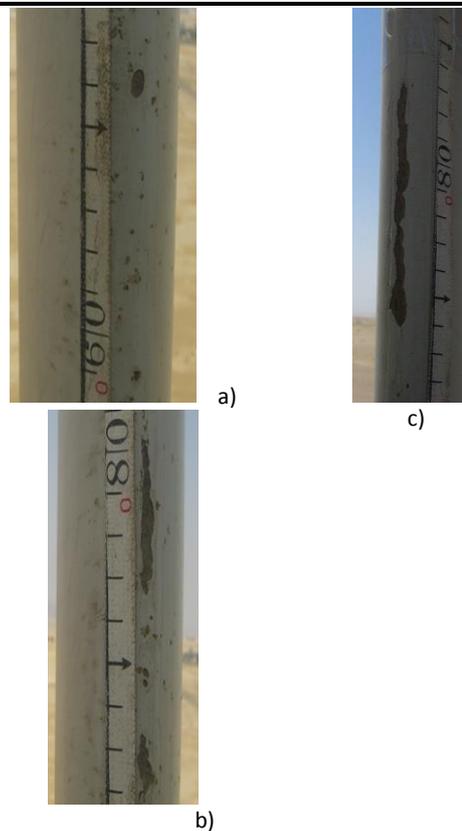
Surface damage is the local removal of gelcoat. This type of discontinuity is found in different forms and sizes, either as rounded areas with a diameter from 2 mm to 7 mm such as the example shown in **Error! Reference source not found..a**, or as elongated to irregular areas up to 9 cm long on the leading edge, as shown in **Error! Reference source not found. b-c**.

Figure 16 a) Small surface damage and insect contamination, b and c) extended surface damage.

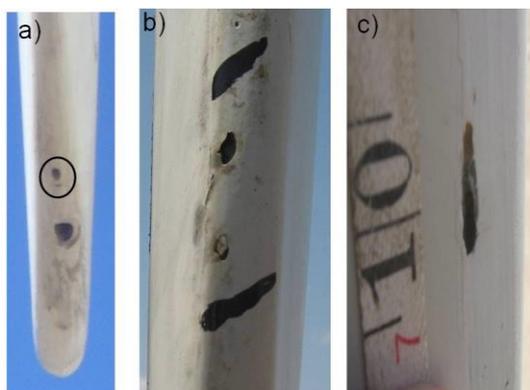
Holes or penetrations are pits of a clear depth through the blade material and have diameters of 3 to 30 mm. **Error! Reference source not found.-a,c** shows some examples of penetrations found in the wind turbine blade. From the distribution of the holes along rotor radius in **Error! Reference source not found.**, it can be observed that the holes are mainly concentrated near the tip of the blade either in the 300 or 100 kW wind turbines. Also, some holes spread along the blade. Some holes have a structural function such as the lower hole in **Error! Reference source not found.-a**, while the others appear during service. **Error! Reference source not found.-c** shows a hole with a depth of 12 mm, which is probability originated during manufacturing as it is covered with gelcoat. Other penetrations could be due to mechanical interaction with external forces.

Figure 18 Holes (penetrations) in the leading edge of the rotor blades (a and c) 100 and b) 300 kW.

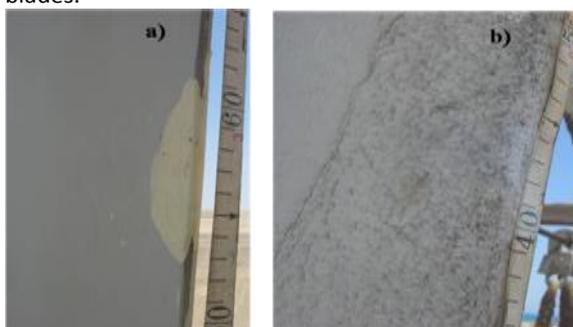
In addition to the above described surface damages, reworked areas are also investigated as illustrated in **Error! Reference source not found..** Surface damages in repaired areas are caused by either untrained technicians or the use of unsuitable materials during the repair process. **Error! Reference source not found.** shows that the size of the reworked area ranges between 3 cm to 100 cm and is distributed over the blade length in the blades of 100 kW turbines, while little number of repaired areas are documented in 300 kW turbines near the tip. Many of the performed repairs need a cosmetic maintenance to improve their surface quality and consequently the aerodynamic performance of the blades.

Figure 20 Examples of repaired (reworked) areas in the inspected wind turbine blades a) 100 and b) 300 kW.
