Failure analysis of heat exchanger tubes of Ni-200 alloy in a titanium tetrachloride vaporizer

^c Cristal Global, Saudi Arabia

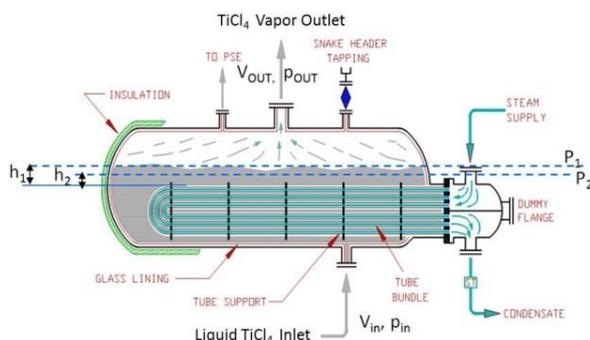
Fig. 1: schematic drawing of titanium tetrachloride vaporizer

It has been found that the tubes were undergoing damage in forms of severe pattern of pitting, leakage, and fracture. The tubes that encountered damage were in the top rows at the bending region in the upper left side in the vaporizer, see Fig. 1. The damage mode and fracture due to thinning after attack of the tubes at the bending region are shown in Fig. 2.

Referring to the operating conditions, the TiCl₄ fluid reaches its highest temperature in the left side of vaporizer (Fig. 1) where it flowed for the longest path in contact with the heating tubes. Furthermore, TiCl₄ is exposed to a relatively higher heating surface density at U-bend tubes in the left side of the vaporizer. Thus, TiCl₄ temperature is expected to increase in this region to temperatures equal to or higher than the boiling point of TiCl₄. In addition to this increase in temperature, the decrease in the hydrostatic pressure to "P₂" due to lowering of liquid TiCl₄ level to "h₂" (Fig. 1) can be less than the vapor

pressure of TiCl_4 . As a result, vapor bubbles are created and begin to rise up, yet the vapor bubbles collapse when they touch the side part of upper tubes resulting in cavitation corrosion, as seen in Fig. 2a. Vapor bubbles may also collapse by subsequent pressure increase.

It is recommended to keep the fluid at a high pressure so that the vapor bubbles are not formed. Also, the sulfur content in the TiCl_4 must be kept at lower levels.

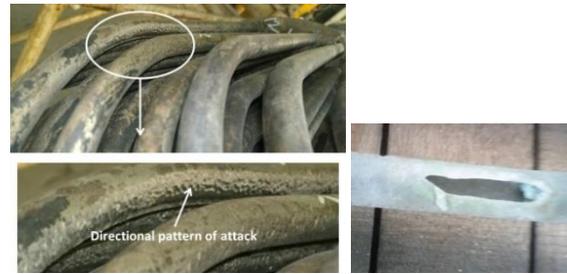
Fig. 2: Damage mode (a) and fracture after thinning (b) on the tubes at the bending region.

Cavitation corrosion causes breakdown of the passive film and rather results in attack on the base metal that leads to thinning of the tube reaching to its crack. The corrosion by sulfur is speculated to occur simultaneously as a lateral mechanism on the bottom of the cavities that act as anodic area free from the passive film. Furthermore, thinning of the tubes can lead to steam leakage that may result in hydrolysis of TiCl_4 according to the equation [17]:

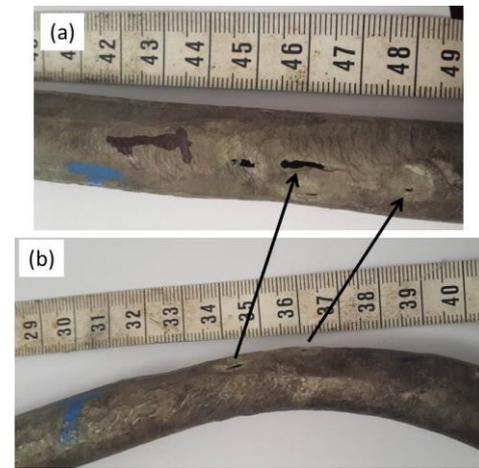
Damaged parts were cut from heat exchanger. Fig. 4 shows deteriorated part of the tube at the bended region. The surface suffered from attack resulting in rough topography, while the outer bent fibers showed severe thinning leading to repeated holes as shown in Fig. 4b. The holes are elongated with the length of the tube coinciding with the thinned outer fiber of the bent tube.

Fig. 4: (a) holes in the damaged pipes at the bended area (b) turning the pipe in 90° and zoom in to the fully damaged.

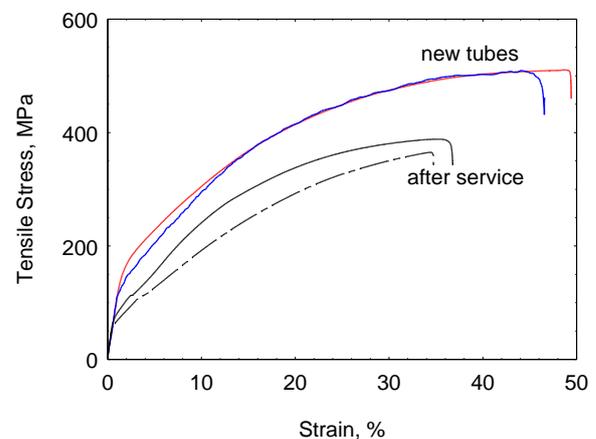
Tensile stress-strain curves of the new samples and the after-service tube samples are shown in Fig. 5. The service life of the old tube samples is around 6 months. The after-service tensile samples showed a clear scattering in the stress-strain curves due to differences in the damage occurred in the tubes, while the new samples revealed a considerable resemblance in the tensile stress-strain curves obtained. Table 2 shows the average tensile test results of the new and the after-service samples. However, the after-service properties showed a clear decrease of the properties due to the damage occurred after the service life.

Fig. 5: Stress-strain curves of the tested new and after service Ni-200 tube.

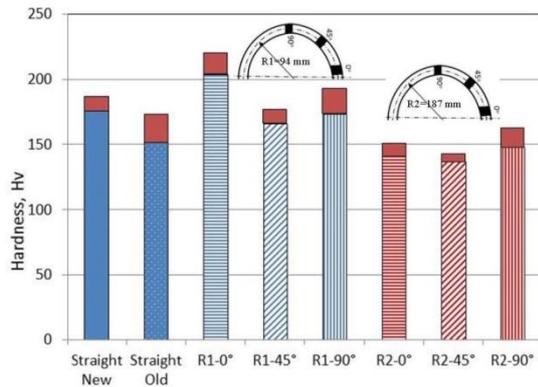
Fig. 6 shows the results of Vickers's hardness testing on new and old tubes as well as at different positions of the bent tubes. The results showed a notable decrease in the hardness of old tube compared to the new one. For the formed tubes, it is clear that decreasing the bend radius has led to higher hardness values that can be accompanied with higher residual stresses. The top part of the hardness columns in Fig. 6 represents the standard deviation, which was high in the samples from the regions (0°) and (90°). At these regions the scattering of the hardness results was significant due to the differences in strain hardening on the outer wall of the tube (tensile side) at differentially deformed positions over the curved part of the tubes. The residual stresses are tensile on the outer tube wall fibers of bending curvature and compressive on fibers of the inner curvature.

The broadly increasing in the hardness values with the decrease in bend radius indicates that the tube material "Ni-200 alloy" is very strain hardening sensitive, as shown from the tensile stress-strain curves, Fig. 5; The alloy started to yield at about 135 MPa and hardened with the strain to reach nearly four times of the yield stress at the ultimate tensile stress of 511 MPa. Because of the absence of subsequent annealing to the forming process, differential material stability due to the different hardening conditions can represent a potential site for corrosion.

Fig. 6: Hardness distribution with error bar at different positions on the radius of curvature of the bent tubes (at 0°, 45°, 90°) as shown in Fig.3.

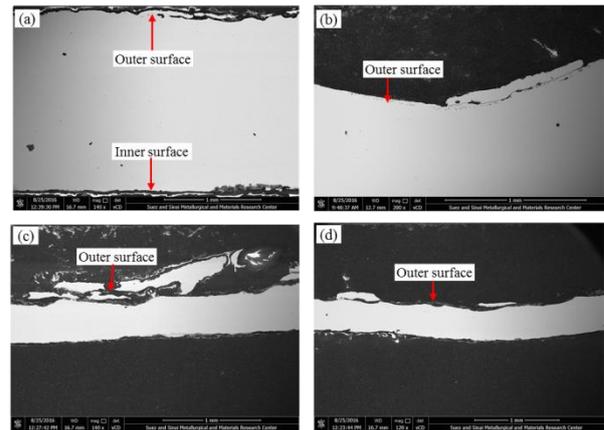
Fig. 8 reveals SEM images at different sites of the damaged tube. Fig. 8a shows a region, which is slightly attacked at the outer surface, while Figs. 8b-d display severely attacked regions that led to thinning of the tube wall. At many regions, the corrosion damage caused separation of metal crusts from the outer tube.

Fig. 8: SEM of polished longitudinal section through a damaged tube walls with different degree of attack.

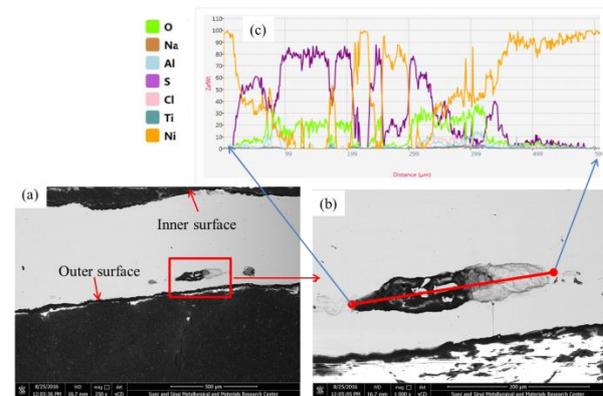
Fig. 9 illustrates the EDX elemental analysis of corroded outer area in the tube. The EDX line analysis through the corroded area (Fig. 9c) shows that S is significantly enriched in the corrosion product, together with a noticeable presence of O. The major presence of Ni and S is ascribed due to the corrosion product of NiS, and the appearance of O in the analysis has been assigned to sulfide oxidation as a consequence of air exposure before the EDX analysis [13]. This has been evidenced by the presence of nickel sulfate as a result of exposure of NiS corrosion layer to air [13].

Fig. 9: (a) SEM of polished longitudinal section in the damaged tube wall, (b) higher magnification of attacked area near the tube surface, and (c) EDX line scan through the attacked region.

NiS has been found to be formed when Ni and Ni alloys are exposed to sulfur species-contained solutions. NiS is a porous film and has no passivation characters. It is reported that the adsorbed S species catalysis the dissolution of Ni and inhibits its passivation [13,14]. S species can be found as HS⁻ or H₂S in acidic solutions and as metastable S₂O₃²⁻ or stable SO₄²⁻ anions in neutral and alkaline solutions [15]. Moreover, S and Cl species, in chloride-contained solutions, can interact with the passive film/solution interface; they have a combined effect on film degradation [15,16].
