An Investigation of Damages in Low Power Wind Turbine Blades

Abstract

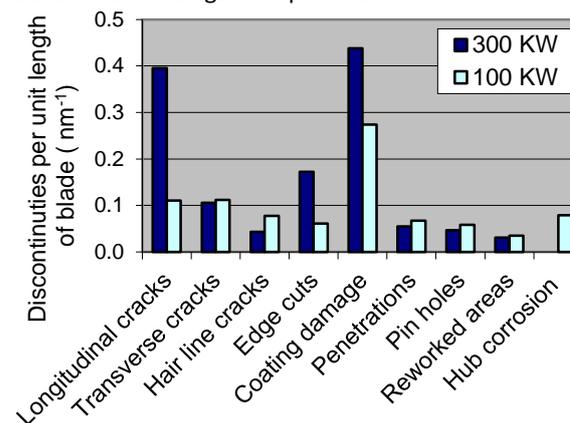
where, the number of the inspected blades B is 18 and 81 and the blade length R_0 is 14.2 m and 9.5 m for 300 and 100 kW power turbines, respectively. Figure 2 illustrates the number of discontinuities per unit length of a blade for both 100 and 300 kW power wind turbines. Clearly, it can be observed that the number of discontinuities per blade length is higher in the 300 kW wind turbine than in the 100 kW wind turbine in case of the longitudinal cracks, edge cuts and coating damage. This trend is reversed for the other types of discontinuities. diagenetic process.

Figure 2 Number of discontinuities per unit length of the blades of 100 and 300 kW turbines.

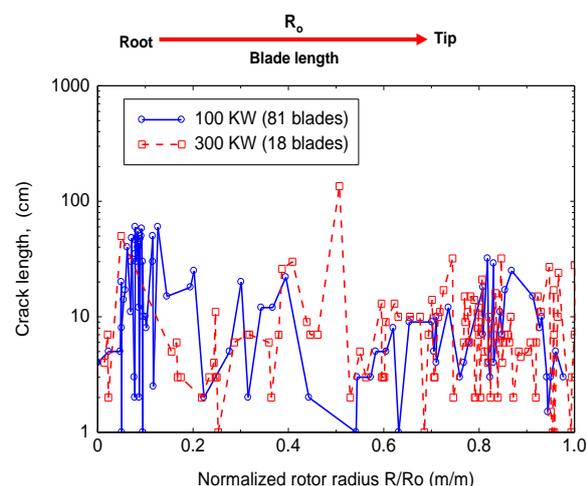
In this figure the blade length has been normalized by dividing the crack location (R) by the blade length (R_0) to represent the data obtained from both types of wind turbine blades (100 and 300 kW). It can be observed that in the 100 kW wind turbine blades the majority of LCs is located near the hub of the blade root and in the cover of the aerodynamic zone [1]. In contrast, in the 300 kW wind turbine blades, the majority of LCs is located near the tip of the blade (**Error! Reference source not found.**). The number of LCs per blade unit length is higher in the blades of the 300 kW turbines, as shown in **Error! Reference source not found.**. The cracks length varies from few centimeters to about 40 cm. The length of one crack in the 300 kW turbines reaches a value of 135 cm. The depth of LCs is determined using a 0.05 mm thin filler sheet. Some of the cracks are up to a depth of 10 mm in the middle of long LCs, while on the rear thirds it hardly reaches a depth of just 5 mm.

The distribution of the discontinuities on the blade length (**Error! Reference source not found.**) implies a frequent occurrence of LCs near the root of the 100 kW blades, while the frequent occurrence of LCs in the 300 kW blades is at the lower third (near the tip).

Figure 5 Distribution of longitudinal crack length along the normalized rotor radius for 100 and 300 kW wind turbines.

LCs should be structurally repaired to extend the life of the working blades.

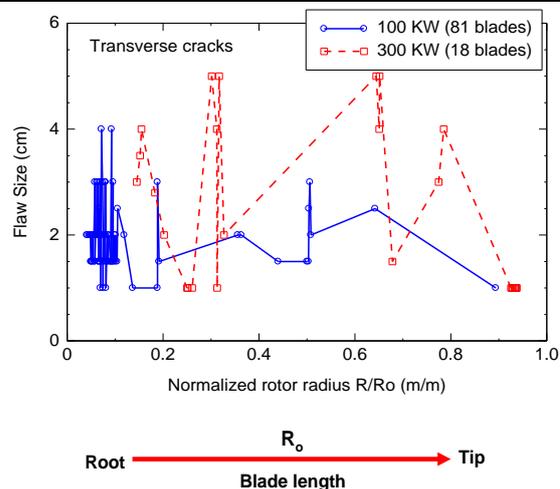
The distribution of the different TCs sizes on the blade length (normalized rotor radius) is shown in Error! Reference source not found.. It is clear that the short root cracks are mainly in the 100 kW turbine blades. Some TCs with a crack length of 5 cm are found mainly in 300 kW turbine blades.

Figure 9 Distribution of the transverse cracks on the normalized rotor radius in 81 blades of 100 kW and 18 blades of 300 kW wind turbines.

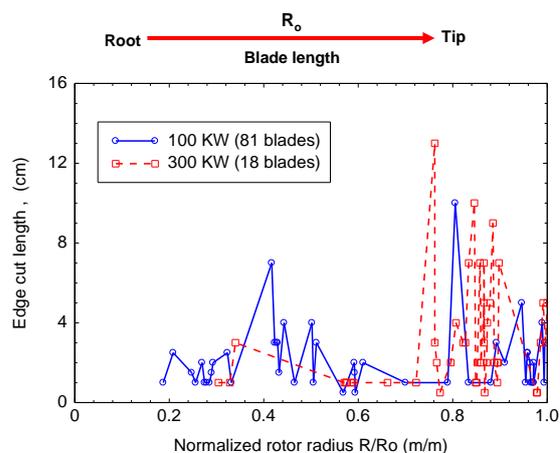
Distribution of the edge cuts along normalized rotor radius is presented in Error! Reference source not found.. The edge damage size is in the rang 1 to 13 cm. It can be observed that the edge cuts on the trailing edge of the 300 kW turbine blades are concentrated in the lower third of the blade, where the edge has very small thickness (reaching few millimeter). This reduces its resistance for crushing by impact of any outer forces.

Figure 11 Distribution of edge cuts along the normalized rotor radius in 81 blades of 100 kW and 18 blades of 300 kW wind turbines..

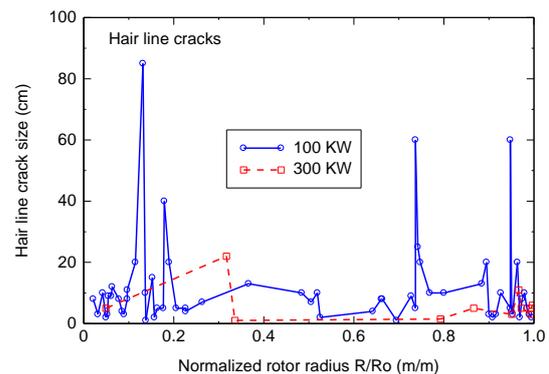
Hair line surface cracks are located in different regions of blades in both 100 and 300 kW turbines, with different sizes as observed in **Error! Reference source not found.**. The size of the surface cracks is specified as the diagonal length of the cracked area, and is in the ranges of 2 cm up to 80 cm.

Figure 13 Distribution of the hair line surface cracks on the normalized rotor radius for 100 and 300 kW wind turbines.

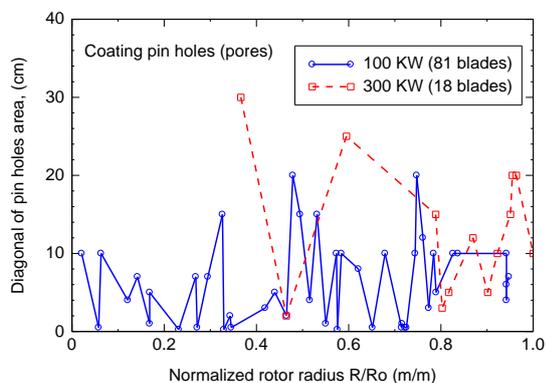
Figure 15 Distribution of coating pin holes (pores) along the normalized rotor radius in 81 blades of 100 kW and 18 blades of 300 kW wind turbines.

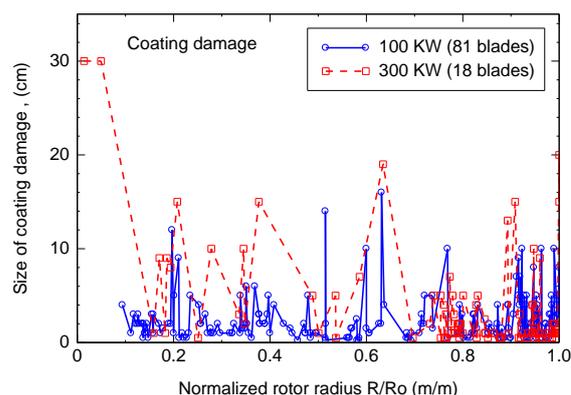
The distribution of this surface damage over the blade length along rotor radius is shown in **Error! Reference source not found..** Higher number of surface damages exists on the lower third of the leading edge of the 300 kW wind turbine blades, while nearly regular distribution of this coating damage towards the end of the aerodynamic section of the 100 kW wind turbine blades is found. **Error! Reference source not found. a-b** indicates that, the coating layer thickness is more than 1 mm. Decohesion of the gelcoat occurred frequently from the bonding materials of the two shell halves or which applied for some cosmetic reason to ensure good curvature of the leading edge. This can easily lead to cracking and separation of such hard thick material with repeated stresses. This damage can affect the inner blade structure even if the effect of climate change and weathering condition are difficult to assess [3]. This coating damage needs cosmetic repair to cover the laminate structure from the environmental aging attacks, i.e. ultraviolet rays (UV), moisture and erosion.

Figure 17 Distribution of coating damage along the normalized rotor radius in 81 blades of 100 kW and 18 blades of 300 kW wind turbines.

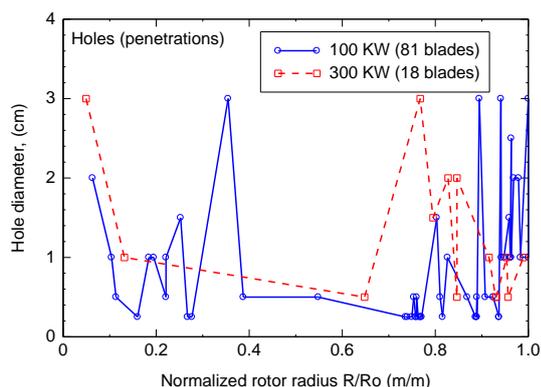
Figure 19 Distribution of holes or penetration on the normalized rotor radius in 81 blades of 100 kW and 18 blades of 300 kW wind turbines .

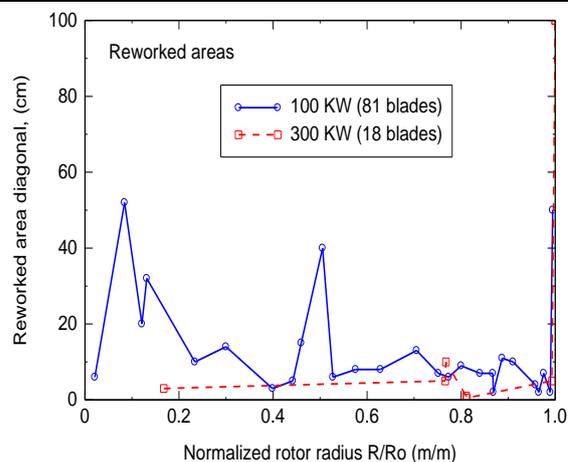
Figure 21 Distribution of reworked areas along the normalized rotor radius of the inspected blades.
