Failure analysis of heat exchanger tubes of Ni-200 alloy in a titanium tetrachloride vaporizer

^c Cristal Global, Saudi Arabia

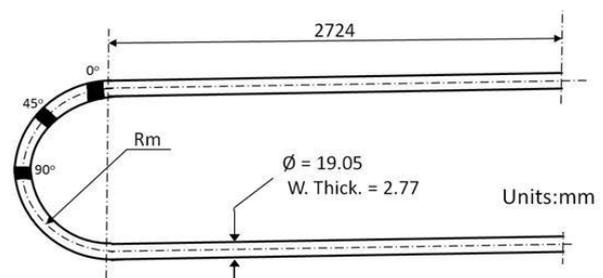
Samples for hardness test were taken from three regions in the U-formed tube as shown in Fig. 3; at the start of curvature (0°), at the mid-way of the curve (45°), and at the nose (90°) of the U-formed tube. The hardness tests were conducted using a low-load Vickers hardness tester with a load of 300 g and dwell time of 30 s.

Fig. 3: U-form bent tube showing some dimensions and the location of the taken samples for hardness test (at 0°, 45°, and 90°).

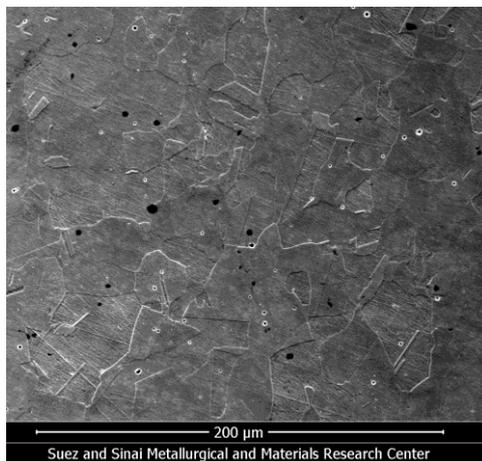
The optical observation of as received Ni-200 alloy (Fig. 7) shows a grained structure with relatively low twinning density. The grain size was around $35 \mu\text{m}$. Twinning are clearly seen in some grains. This type of defect is often observed in metal and alloys with FCC structures. Twins in Ni-200 alloy under investigation are confined inside the grains, in contrarily to annealing twins that are characterized by straight

lines extending across the grain boundaries [11]. Ni-200 alloy has been reported to have a single phase and has a microstructure similar to that of austenitic stainless steel [12].

Fig. 7: Optical micrograph of the Ni 200 alloy.
